Manhole Inspection Summary

Manhole # S21K1_001MH

Location Address: **3013 w patapsco-marbourne alley** Cross Street: **hollins ferry rd**

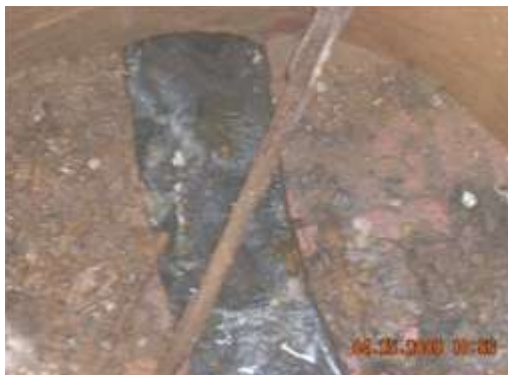
Defect 4

Condition: ☐ Sound ☐ Cracked ☐ Root Intrusion ☐ Deteriorated ☐ Leaks ☒ **Debris**

debris in channel

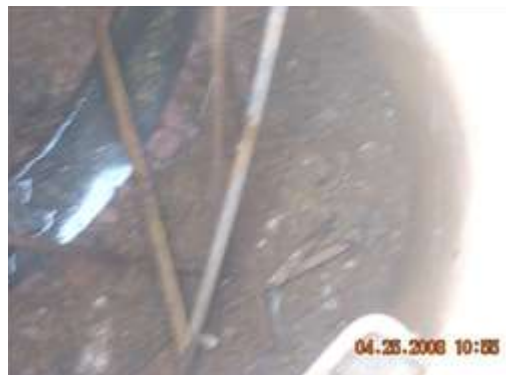
Defect 3

Condition: ☐ Sound ☐ Cracked ☐ Root Intrusion ☐ Deteriorated ☐ Leaks ☒ **Debris**

debris on bench

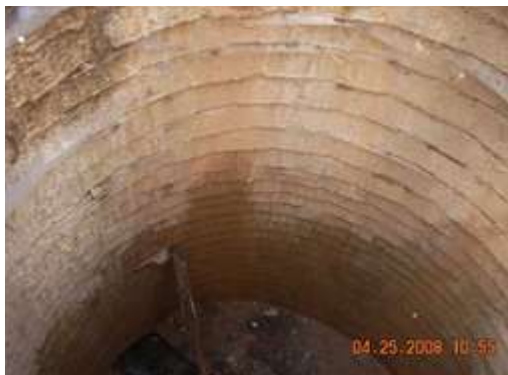
Defect 2

Infiltration: ☐ None ☐ Joint ☐ Cracks ☐ Mortar ☐ Roots ☒ **Wall**

infiltration @ barrel wall

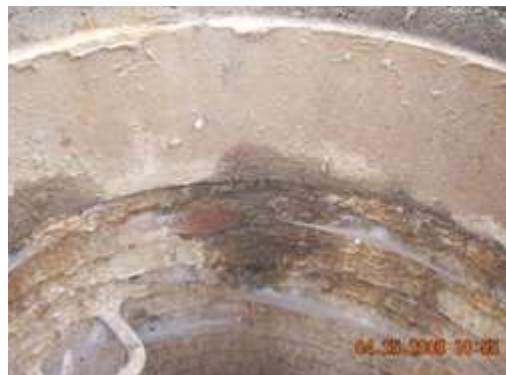
Defect 1

Infiltration: ☐ None ☒ **Joint** ☐ Cracks ☐ Mortar ☐ Roots ☐ Wall

infiltration @ corbel/frame joint

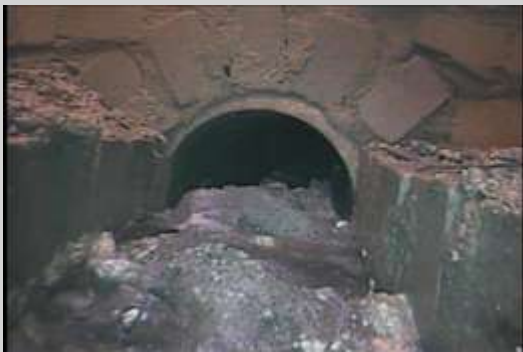
12 O'Clock Outflow

Channel debris

Pipe Height: **7.2** (in.) Rod and Bar (Angled)
Pipe Material: **Clay** ☐ Pipe Lined
Invert Depth: **6.72** (ft.) Flow Characteristics: **Slow**
Deposits: ☐ None ☐ Mud ☒ **Sludge** ☒ **Debris** ☐ Grease
Silt Depth: **4** (in.) Deposits Extent: **Heavy**
Infiltration: **None** Pipe Seal Cond: **Sound**

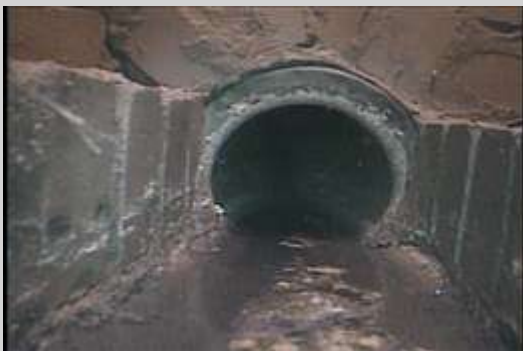
4 O'Clock Inflow

Pipe Height: **6** (in.) Rod and Bar (Angled)
Pipe Material: **Clay** ☐ Pipe Lined
Invert Depth: **6.60** (ft.) Flow Characteristics: **Slow**
Deposits: ☐ None ☐ Mud ☒ **Sludge** ☐ Debris ☐ Grease
Silt Depth: **2** (in.) Deposits Extent: **Light**
Infiltration: **None** Pipe Seal Cond: **Sound**
